Jac 1900D frame repair – Bill Carr

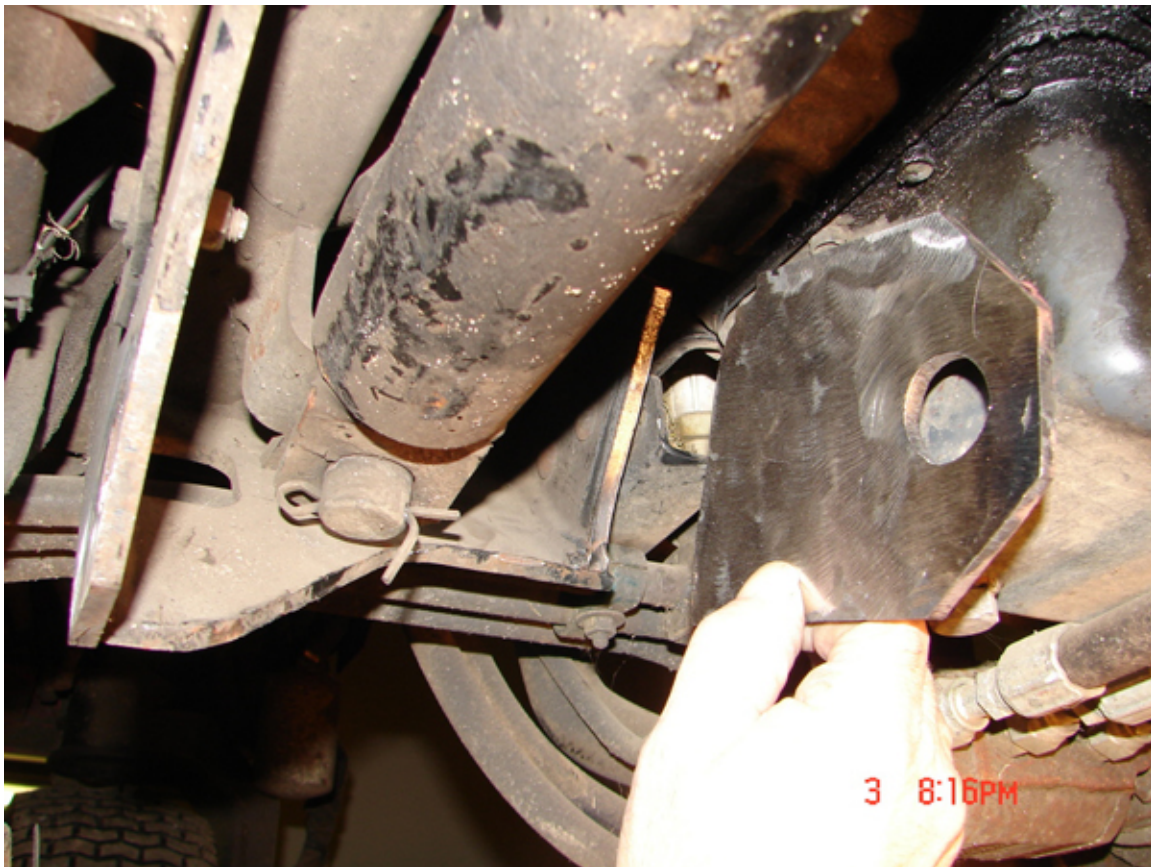
For those of you that may own one of these this may save you some grief. As you can tell in the below photo the framing that supports the rear reel broke completely off. The left side of the framing seems well supported but the right side lacks. On the pivot pin it had appeared at one time someone had put in two cotter pins on both sides-apparently on the left side there is supposed to be a locking bolt on the cotter pin to keep the pin from spinning. With no locking mechanism in place, the pin warped out the holes in the framing and caused undue stress to the frame, resulting in a breakage. Note in pic the piece I am holding I already rewelded the hole completely shut and redrilled.
