#### Convoluted Wrench - Eric Kulaas

Posted by EricKulaas on  
Saturday, 28 August 2004  
(17:34:58) Central Daylight  
Time  
Contributed by EricKulaas

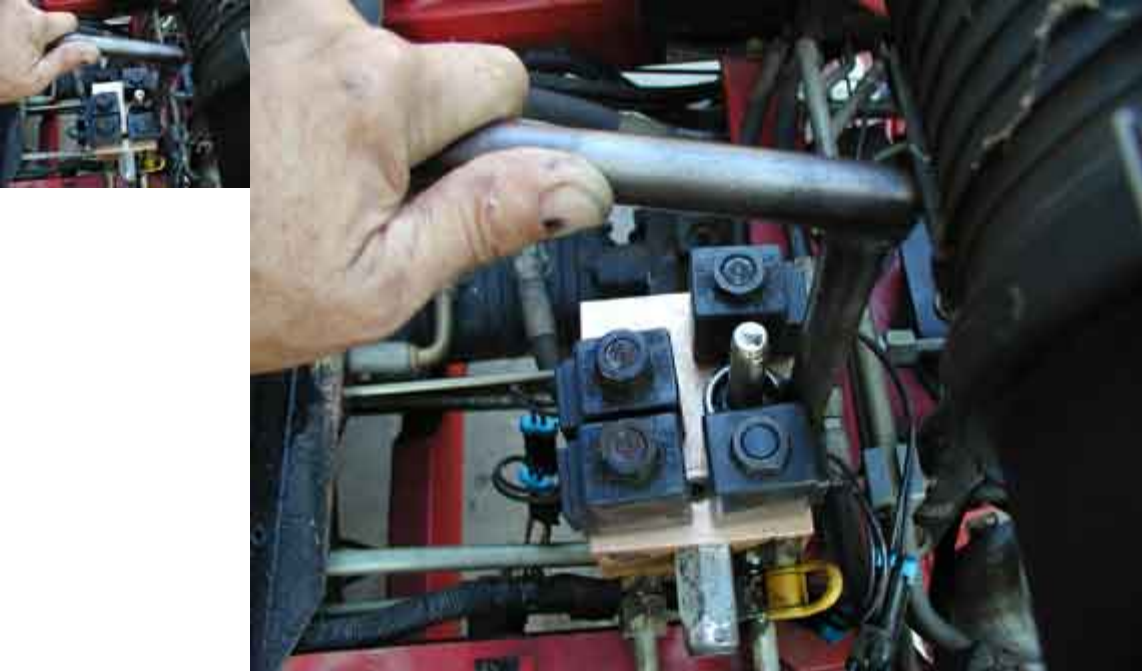
Early on, to pull some of these out was a chore. Sometimes you'd have to pull out the two beside it to get a wrench on it. Deep sockets wouldn't work as the valve stem was too tall. What we came up with was our own wrench. To make it, cut off the 12 point wrench end. Weld that, perpendicular to a 3/4 roller shaft. I made ours about 10 inches tall. Then weld another section of roller shaft at 90 degrees to that. In a reverse fashion. This allows you to slip it in to any valve and remove it without taking anything else apart.

Over the years Toro has increased the use of their electric hydraulic valves. My first experience with these was on the early 5100-Ds in the early '90's. They are fairly reliable, at least when you learn their in's and out's. Initially the problems we had were mostly related to moisture. The shaft under the solenoid would corrode. Then you could have a lost contact or reduced "pull".

Over the years we learned that the best preventative maintenance we could come up with was to coat them with Club Car battery Terminal spray. Soak everything. This waterproofs better than one would think. It's also easy to clean in case you do need to pull one out.
