## **Club Car Precedent Battery Bucket Fix**

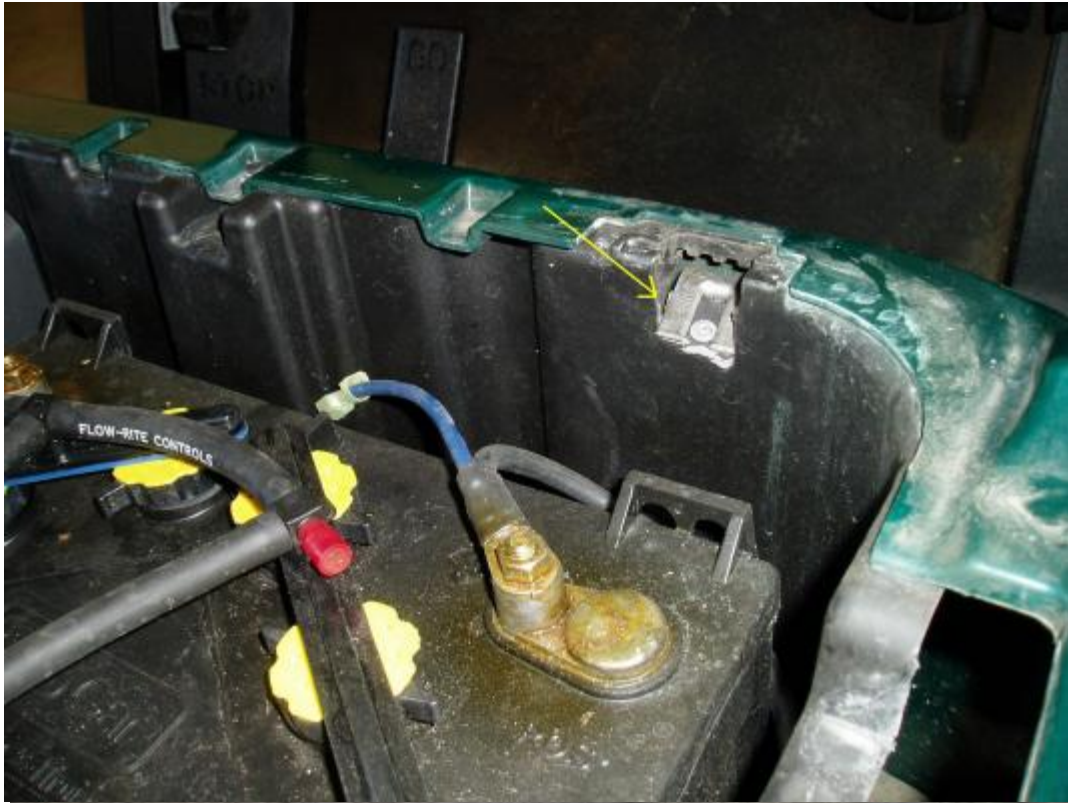
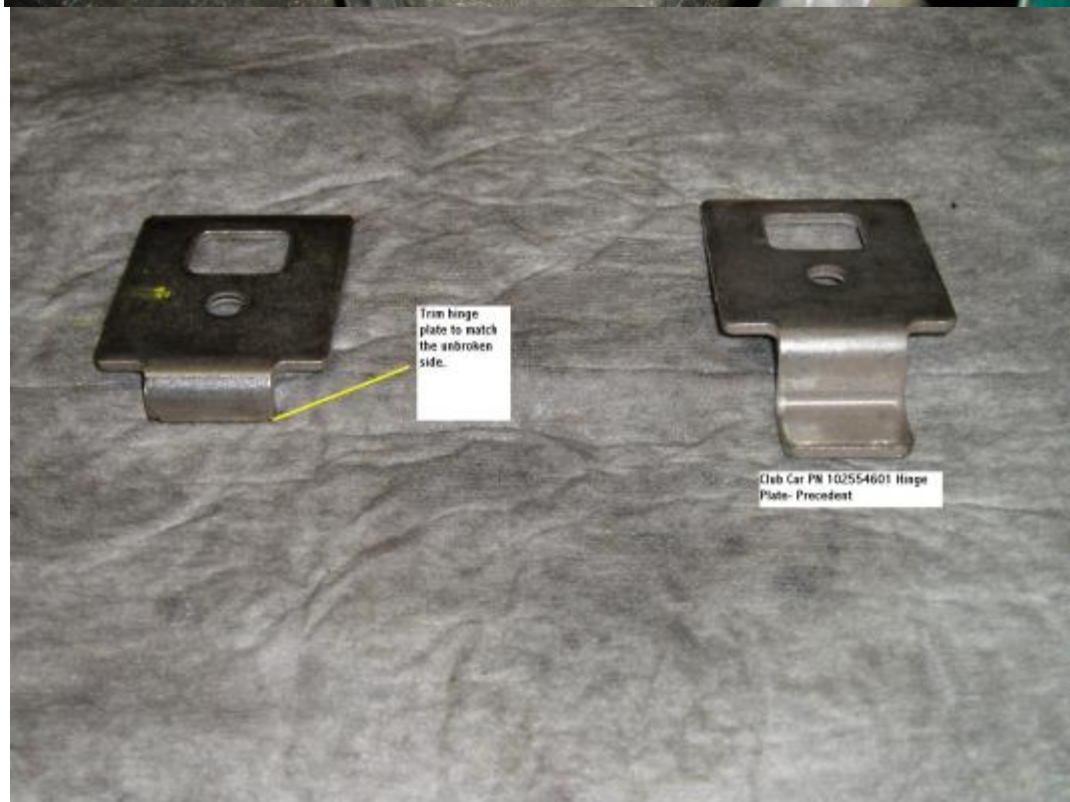
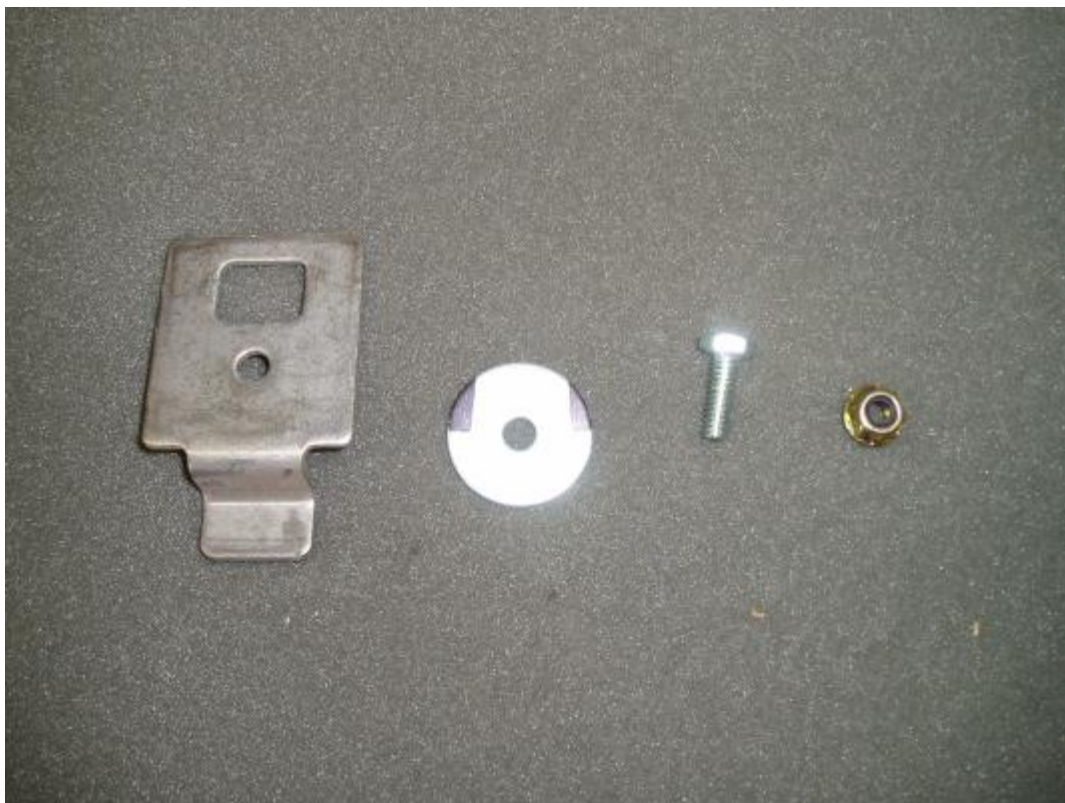
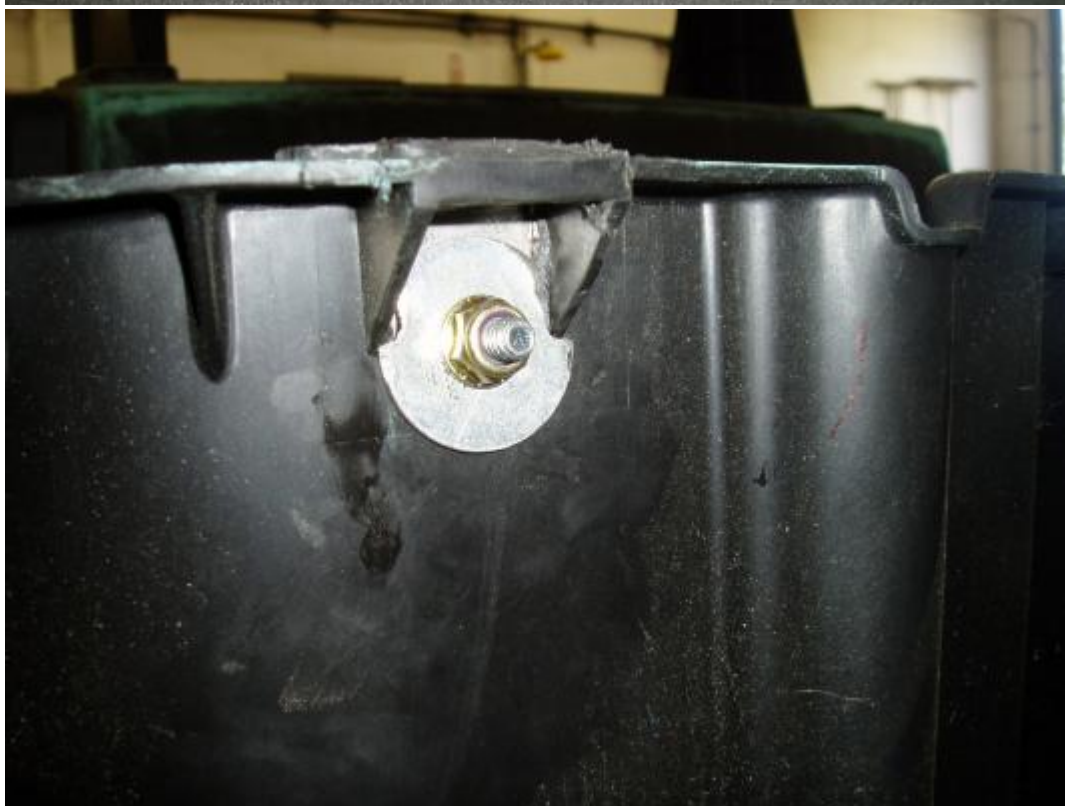
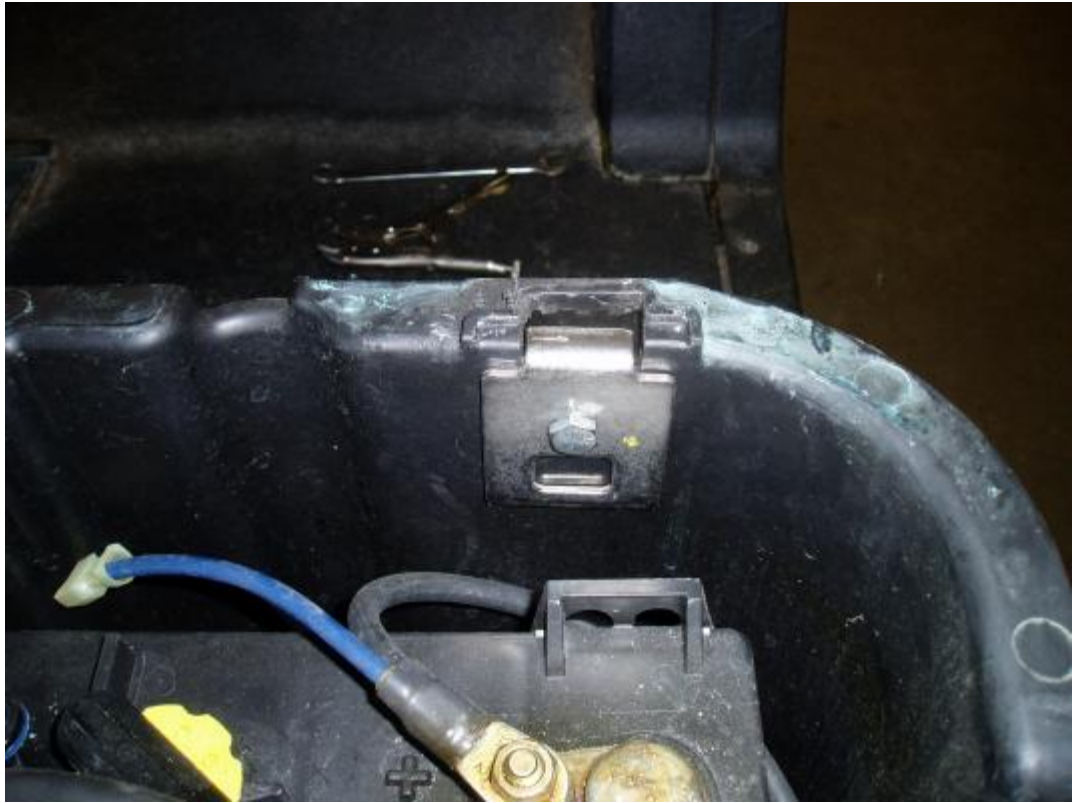
The seat hinges on Club Car's Precedent are integrated into the battery bucket. If the seat is improperly hooked into the hinge receiver, the plastic may break, and not properly secure the seat. When this happens, the entire battery bucket needs to be replaced to repair it. I've had this happen a few times, and it's rather time consuming, and expensive to fix. I came up with a solution that has worked great, is cheap, and only takes about 20 minutes.

Parts required:

1- Club Car 102554601 Seat hinge, trimmed as shown in pic.

1- 1/4x3/4" bolt

1- 1/4x1 1/4" fender washer, grind the edges to fit.

1- 1/4" lock nut.
